Service Bulletin

Bulletin No.: 21-NA-269

Subject: Instrument Panel Cluster Driver Information Center (DIC) Intermittent Blank Screen

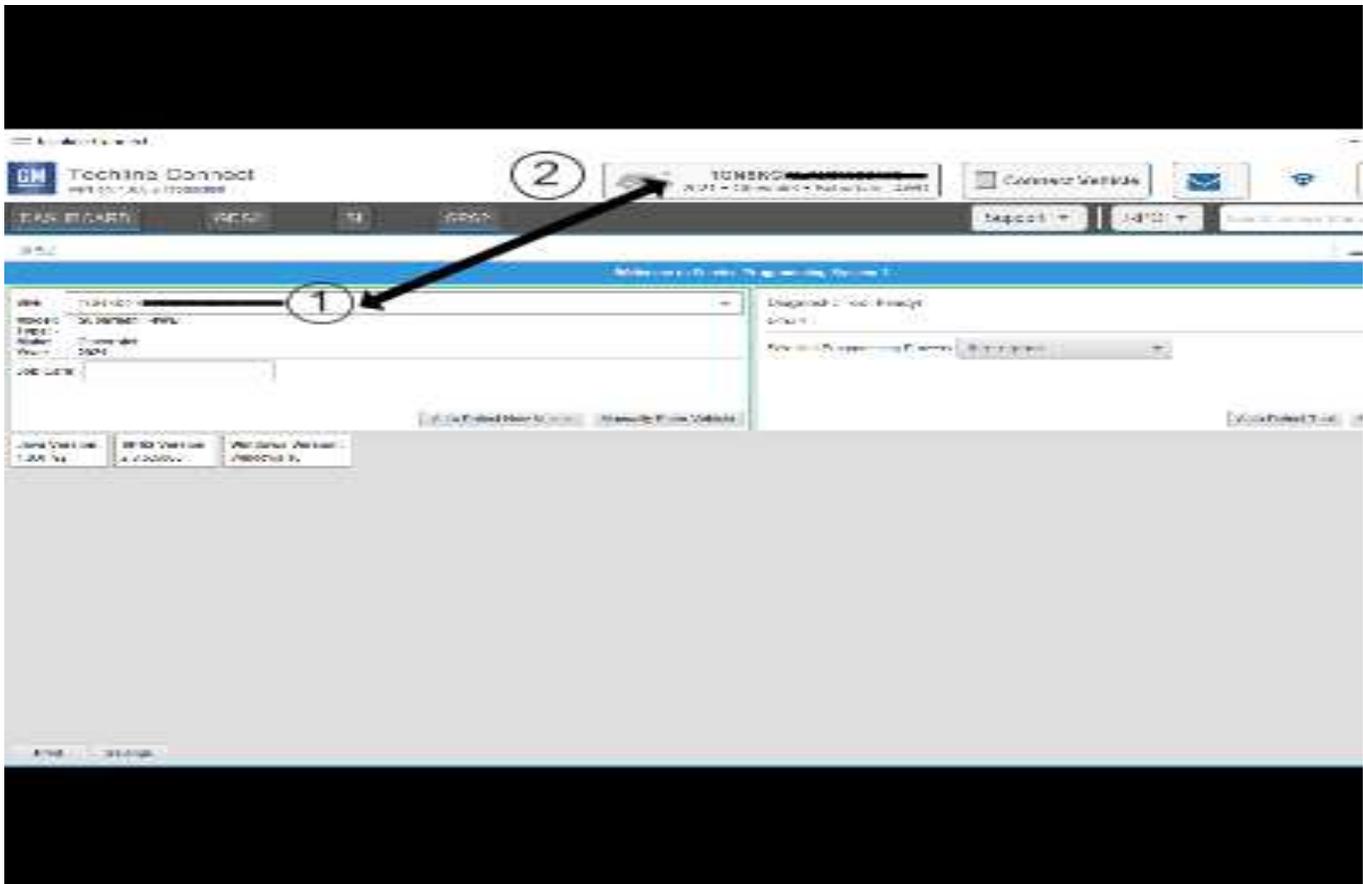
Caution: Be sure the VIN selected in the drop down menu (1) is the same as the vehicle connected (2) before beginning programming.

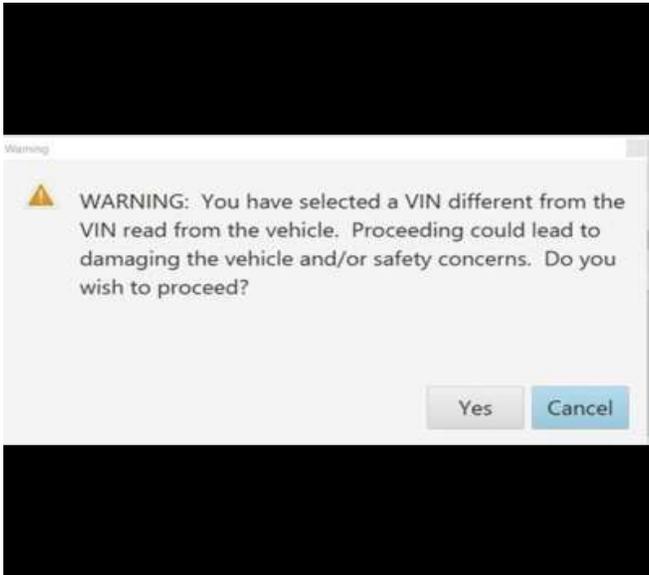
5877000

Important: If the vehicle VIN DOES NOT match, the message below will be shown.

Important: Techline Connect and TIS2WEB screens shown above.

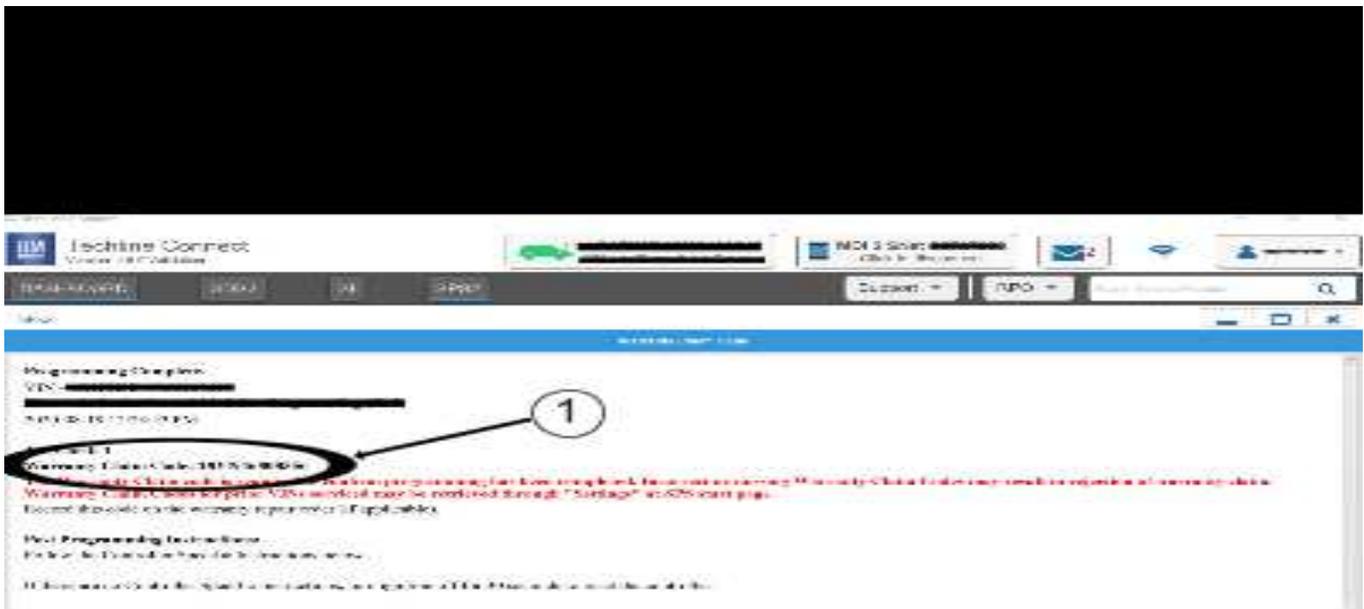
5644478

Note: The screenshots above are an example of module programming and may not be indicative of the specific module that is being programmed. Module selection and VIN information have been blacked out.
